Health, Safety, Quality and Environmental Alert	Alert number: 42-14	Document Reference: AMG/F/HSQE/001
	Burns following exposure to electric short circuit	Issue Date: 30/12/14	Author: Steve Milroy

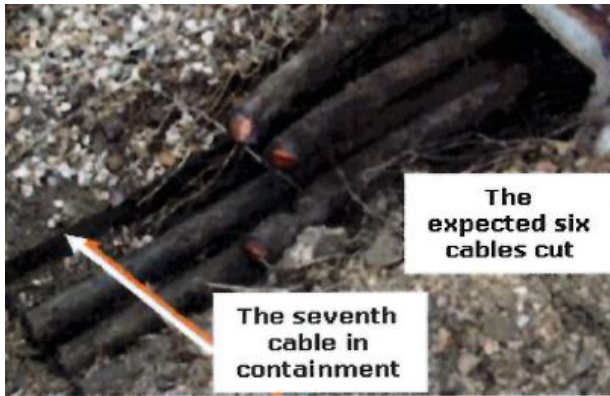
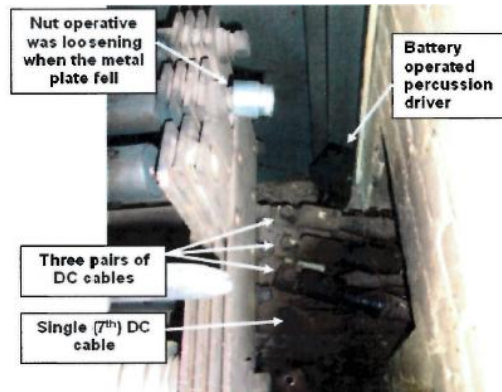
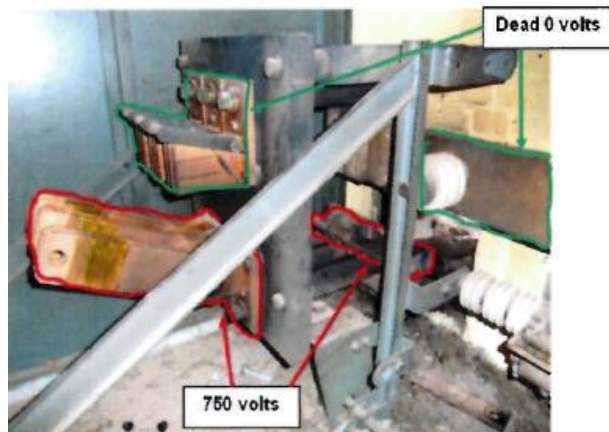
A dismantling operative was taking electrical equipment believed to be redundant apart when a plate he was unscrewing fell striking a busbar that was live. The operative received burns to his hand and face.

A Steel plate came into contact with live 750v DC cable end causing electrical flash over.

Always test before touch.

Always confirm the number of cables connected to a busbar – this is the second time an odd number of cables has been discovered
