# SAFETY ALERT

On the 12th January at 03:00 hours a Machine Operator suffered an injury to his right ankle, when a 709ft rail slewed and struck the Machine Operator on his right ankle.

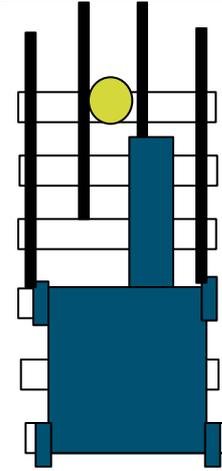
The accident occurred when the Machine Controller requested a spanner from the Machine Operator in order to tighten the locking pins on the clamp. The Machine Operator leaned forward in his cab to pass the spanner and in doing so accidentally moved the jib lever causing the rail to move.

The rail struck the crane controller on the right ankle. Due to another piece of rail in the 4ft and the fixed track the ankle may have been crushed as well as struck.

- Failure to recognise the risk that movement of the machine jib presented to the machine controller stood in the 4ft.
- This lead to the operative not taking the action to stop the machine and make sure it could not move before attempting to reach around in the cab to find tools. It also lead to the machine controller not moving to a safe position.
- Not considering the risk of the clamp slipping at the start of setting up the clamp and securing the lock nut at the time of preparing for the lift. The use of a panel grab as apposed to a thimble to support the CWR is also being reviewed.
- This accident is subject to an investigation, using the Life Saving Rules, fair culture matrix.
