Health, Safety, Quality and Environmental Alert	Alert number: 22-15	Document Reference: AMG/F/HSQE/001
	Slip/Trip/Fall Accident at Hither Green	Issue Date: 10/03/15	Author: Steve Milroy

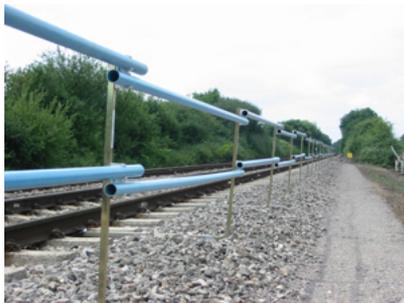
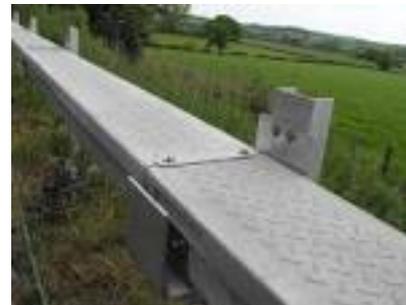
The IP was walking along the Ballast Shoulder area at the time and was Track side of the Vortex Fencing meaning that as he reached out to support and steady himself he grabbed the Vortex Fencing and it subsequently gave way due to the nature of the design.

It is designed to act as a rigid barrier when CESS side but as a safety mechanism is designed to release from its fixings should pressure be applied from the Track Side and therefore was proved from a design perspective but proved ineffective when the IP grabbed it to prevent themselves from falling.

The IP then fell against the GRP Troughing Route, jarring and bruising their lower back area. The IP visited hospital as a precaution where the injury of bruising was confirmed.

Example of Vortex Fencing Similar to that on site and an example of the GRP similar to that which the IP fell against.

- Always observe where you are walking and the hazards in that location
- Take extra care when walking up and down any type of inclined surface including ballast shoulders
- Look ahead to observe hazards and warn other members of the team
