Health, Safety, Quality and Environmental Alert	Alert number: 41-15	Document Reference: AMG/F/HSQE/001
	Rail Lifting Beam Failure	Issue Date: 12/06/15	Author: Steve Milroy

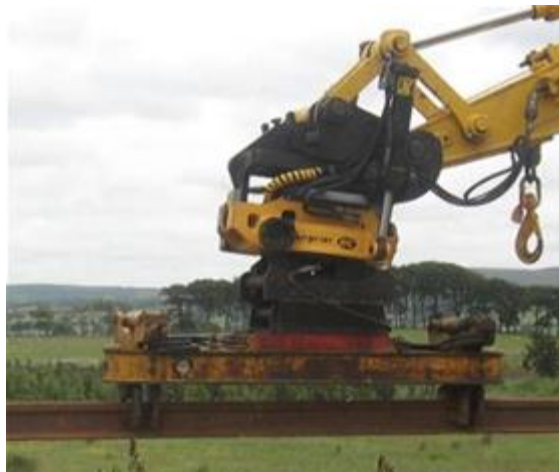
On 14 May 2015 a rail beam, being used to lift a 60ft section of rail, failed when the bolts securing the hitch adaptor plate to the main beam were stripped of their thread.

Reports indicate that the operator of the road rail excavator crane was attempting to lift a section of rail from the end, rather than in the centre as required by the Infrastructure Plant Manual NR/PLANT/0200/module P517.

It was possible to attempt the operation in this manner due to the beam being directly fitted to the tilt rotator, rather than the rotator being fitted to the dipper nose pin or via a flexible intermediate linkage onto an approved lifting point.

Lifting rail in this manner is not permitted as it will overload the lifting components and may cause complete failure as occurred in this instance.
