<b>Health, Safety, Quality and Environmental Alert</b>	Alert number: 35-14	Document Reference: AMG/F/HSQE/001
	<b>Safe Use of Ironmen</b>	Issue Date: 11/11/14	Author: Steve Milroy

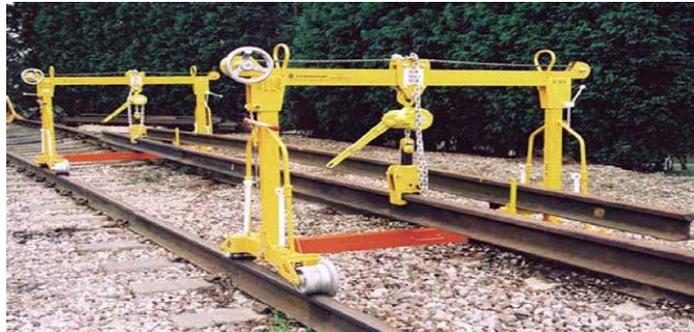
On 1 November 2014 a group of trackworkers were moving 2 x 52ft pieces of rail for approximately a mile and a quarter on the line between Pantyffynnon Jcn and Gwaun-cae-Gurwen in Wales using two pairs of Ironmen.

The Ironmen were being operated down a gradient which was up to 1 in 40, with the load for each pair being just short of 1 tonne. The rail head was contaminated with leaves and it was raining heavily at the time.

Both pairs of Ironmen experienced difficulties during braking; this resulted in them gaining speed to the point the operators could no longer control them. One of the operators of the first pair received a graze injury and another suffered from shock.

**Subsequent inspection of the brakes has shown them to be worn.**

Before further use, all Ironmen shall have additional maintenance carried out by the maintainer. The maintenance shall follow the full maintenance requirements for brakes contained in the user guide or handbook.

- Ironmen shall not be used on gradients greater than **1 in 150** until further notice.
- Staff are reminded that a brake test is required at the start of every shift (rotational tests) and once mounted on rail (prior to loading).
- The requirements for planning, operating and maintaining Ironmen including the number of staff required to control the equipment based on the load are contained within NR/PLANT/0200/modules P501, P514 and P702 *Infrastructure Plant Manual*.
