<h2 style="text-align: center;">Health, Safety, Quality and <b>Environmental</b> Alert</h2>	Alert number: 04-15	Document Reference: AMG/F/HSQE/001
	<h3 style="text-align: center;">Serious Eye Injury (Update)</h3>	Issue Date: 11/01/15	Author: Steve Milroy

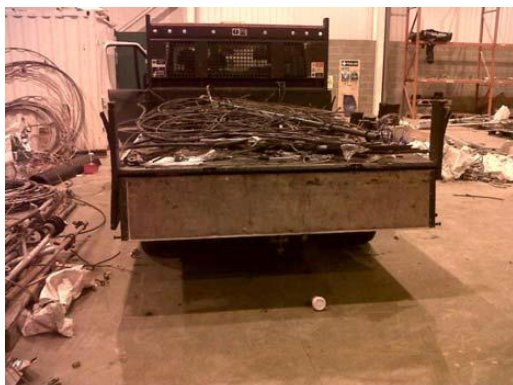
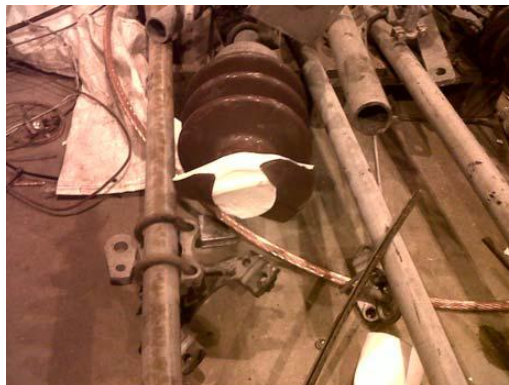
- Whilst unloading a vehicle inside Stockley depot on Tuesday 30<sup>th</sup> December, a porcelain insulator pot rolled from the flatbed falling to the ground and subsequently shattered. Fragments flew up and a shard went into the eye of a trainee OLE Lineman standing nearby.
- He was taken to hospital by ambulance and later transferred to a specialist eye unit where he received emergency surgery. Sadly, he has permanently lost the sight in his left eye.
- It is believed that Safety Glasses were being worn at the time of the accident.
- A full investigation is ongoing by the Principal Contractor.

- All activities must be properly planned, managed and documented.
- Ensure all tasks have been suitably risk assessed and **task specific PPE** is being worn.
- A Task Briefing Sheet (TBS) must cover the actual task being undertaken with specific risks and mitigations.
- Adequate levels of supervision must be maintained at all times.
- Good housekeeping and material storage must be maintained at all times.
- Waste management plans must be in place with the necessary contingency arrangements to ensure there is a sufficient quantity of skips available.
- The risks associated with the handling of insulator pots must be considered.
