<b>Health, Safety, Quality and Environmental Alert</b>	Alert number: 33-15	Document Reference: AMG/F/HSQE/001
	<b>Hydraulic Oil Enters Eye</b>	Issue Date: 15/05/15	Author: Steve Milroy

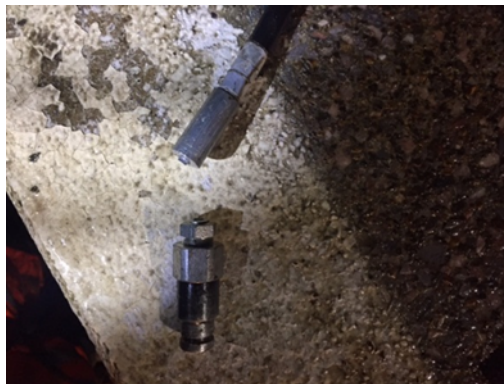
The team were stressing the 6ft rail (Conductor Rail Side) within Fishbourne station limits. The kit was under pressure and keying up had commenced when one of the hydraulic hose metal connectors snapped and the hose spurted oil in the air, a member of the PWay staff was standing in the vicinity approximately 4ft away and oil made contact with the individuals left eye. The member of staff was immediately taken to Hospital where he had the eye washed and was discharged with no ill effects to the eye.

Photograph showing hose connector snapped.

Hydraulic hose connector snapped. All kit was within calibration date and due for retesting on 4th June 2015. There were no visual signs of damage prior to use of the equipment.

- All staff to wear safety glasses on or near the line, In a situation where the wearing of safety glasses is causing poor visibility due to weather conditions then the risk assessment undertaken by the team leader or person in charge must consider the specific task and risks where the staff are working
- All teams to have eye wash facility available on site or in first aid kits

- How the equipment is maintained and serviced
- Could the hydraulic hose metal connectors have been damaged whilst being transported
