Health, Safety, Quality and Environmental Alert	Alert number: 03-15	Document Reference: AMG/F/HSQE/001
	Train Trolley Collision	Issue Date: 11/01/15	Author: Steve Milroy

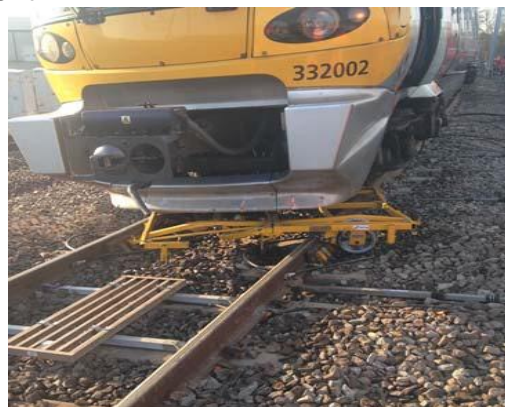
At approx. 09:55 on Sunday 28th December, 1Y40 0948 Heathrow to Paddington struck and ran over a track trolley on the Up Airport Line at Stockley:

- No task briefing for activity to be undertaken.
- The trolley had been placed on a line open to traffic at line speed.
- The two man gang who were with the trolley managed to move clear and were uninjured.
- The gang had accessed the line after removing a demarcation fence without the COSS being present.

Trolley Under Train

- Only ever use an authorised access point.
- Always ensure that you understand the worksite limits.
- Ensure task briefing covers all activities to be undertaken.
- Always ensure you have a clear understanding of which lines are open to traffic.
- Clarify with your COSS any information you are unsure of.
- NEVER interfere or remove a safety barrier.
- Do not access the track or start work on the track without your COSS being present.
