<b>Health, Safety, Quality and Environmental Alert</b>	Alert number: 32-15	Document Reference: AMG/F/HSQE/001
	<b>Mobile Elevated Working Platform – safety device override</b>	Issue Date: 08/05/15	Author: Steve Milroy

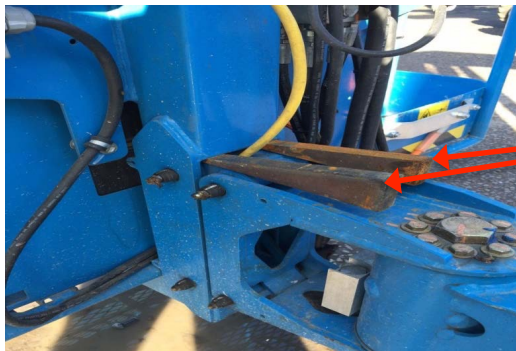
We have been contacted by Nationwide Platforms after a subcontractor's Mobile Elevated Working Platform (MEWP) was inspected following its use on one of our sites. The inspector identified that two metal wedges had been placed to the rear of the cage to stop the overload sensors.

Overriding a safety feature such as the overload sensor could allow the machine to become top heavy and prevent any warning that it may become unbalanced or even tip over. In the event of this occurring, the operator is at severe risk of being ejected from the basket or suffering impact injuries. Safety features are there to protect us and disabling them is extremely dangerous. Machines with compromised safety mechanisms must not be used.

Wedges inserted to override the overload sensor

- Staff to be aware of the method used to override the overload sensor
- More vigilance required during site inspections and MEWP acceptance checks
- A full investigation has been launched with the subcontractor
- CCTV footage clearly identified the operator over loading the basket • CCTV footage clearly identified the operator inserting the wedges
- The subcontractor has disciplined the operator concerned, implemented refresher training and a monitoring process
- The incident is to be discussed at all senior meetings and information is to be circulated across the business.
- Regular daily checks on all MEWPS
