Health, Safety, Quality and Environmental Alert

39-15

Ironman lifting incident

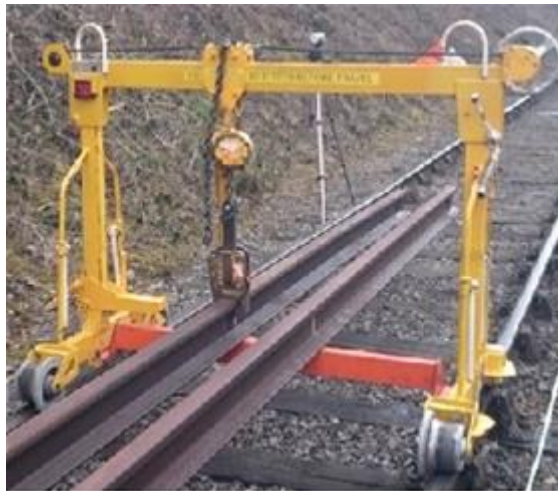
On 3 June 2015 an incident occurred during a lifting operation involving a Permaquip ironman. Whilst lifting a 60ft length of rail a bolt in the pull lift sheared causing the rail to fall to the ground.

Permaquip ironman equipment

When using Permaquip ironman equipment to undertake a lifting operation, individuals must ensure they stand clear of the suspended load.

Supervisors and managers of work involving ironmen should make sure that all of their team know of the failure and understand why they must stand clear of the rail throughout its whole length.
